Aesthetic integrations in the restoration process of mural painting

Inna Ostrovsca¹

Faculty of Architecture and Urbanism, Politehnica University of Timisoara, Romania¹
innaandriana15@gmail.com¹

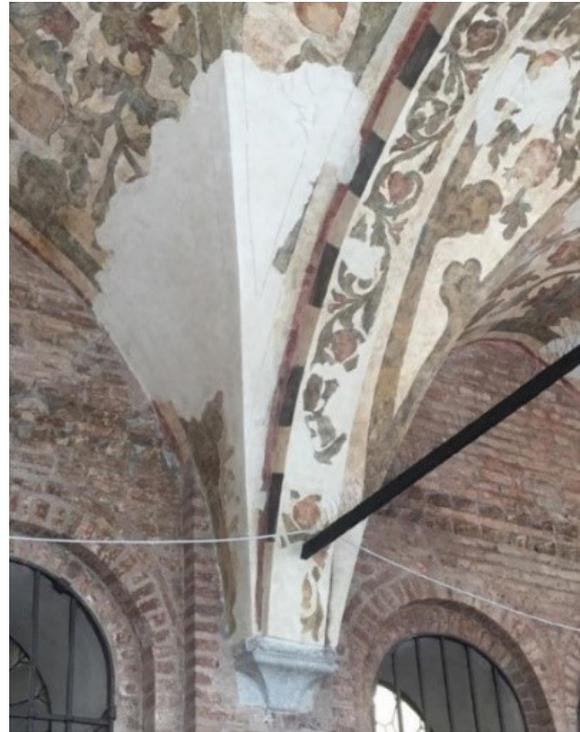
Fig. 1. Palazzo della Ragione (Padua), Restoration works took place in 2000. (no chromatic integration performed)

Current solutions cover a wide range of possibilities from minimal or no chromatic integration (see Fig. 1), to the reconstruction of lost content based on archival photographic documentation. The contemporary view is that restoration is part of the concept of conservation, which encompasses all measures and actions aimed at safeguarding tangible cultural heritage while ensuring accessibility to present and future generations [2].

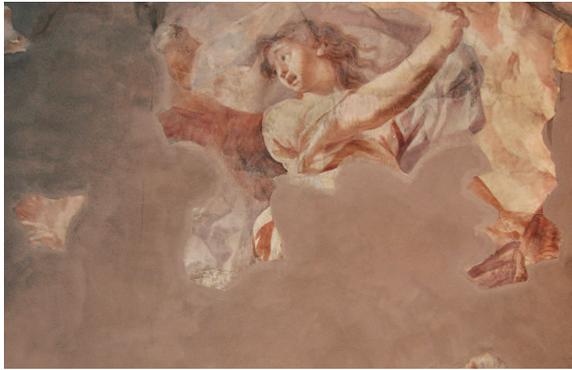
Fig. 2. Church of Santos Juanes, Valencia (Spain), 1698-1700; Photo: 2015, UPV (Jose Luis Regidor) [9]

- Technique “neutro” - When a degraded area or lacuna cannot be reconstructed due to its size, lack of reliable sources, or the artistic im-

portance of the work of art, its negative optical impact on the original can be reduced by toning down the lacuna with a so-called “neutral” colour, thereby moving it into the background (see Fig. 2).

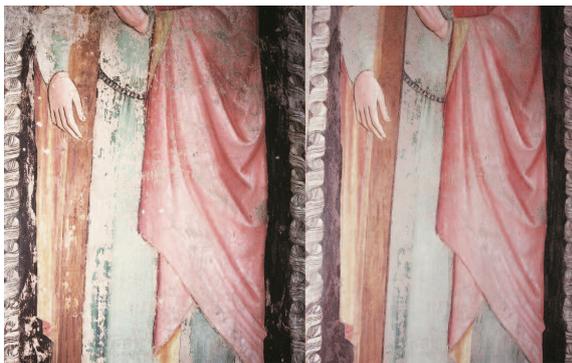
- Technique “velatura” - small losses in the paint layer, in the preparatory layer or the final layer of an architectural surface, caused by wear/use, abrasion or other damage, are reintegrated by means of reducing the tone with transparent glazes, applied using watercolours or any other compatible and adequate binding media (see Fig. 3).

Fig. 3. Before/after velatura on a column, Cappella Maggiore di Santa Croce, Florence (Italy), 1380; Photos: 2010, OPD (Maria Rosa Lanfranchi) [9]

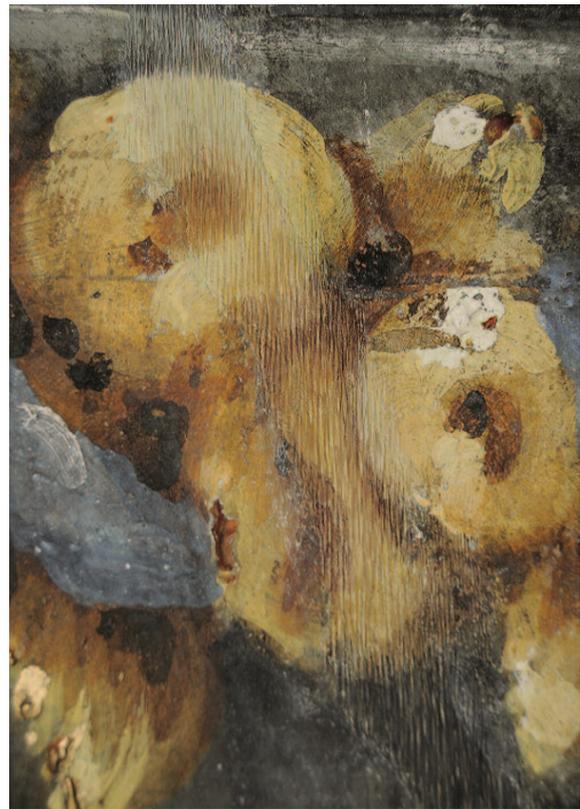
Fig. 4. Church of San Nicolás Obispo y San Pedro Mártir, Valencia (Spain) 1694/1700; Photo: 2014, UPV [9]

- Technique “tratteggio” - Based on the conservation/ restoration theory of Cesare Brandi, the shape and colour of a damaged area are reconstructed using short vertical lines (see Fig. 4).

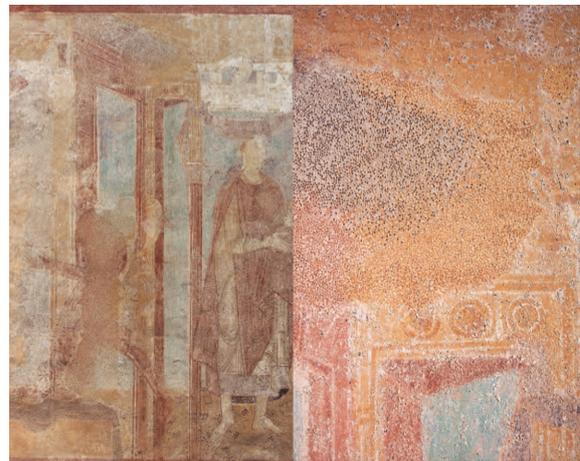
Fig. 5. Ottonian Cycle, St. Georg, Reichenau-Oberzell (Germany), 10th century; Photos: 1988, RPS (Dörthe Jakobs, Helmut F. Reichwald) [9]

- Technique “punteggio” - The colour, and not necessarily the shape of the damage or lacuna is reconstructed using a dense application of dots, wherever possible in pure colours (see Fig. 5).

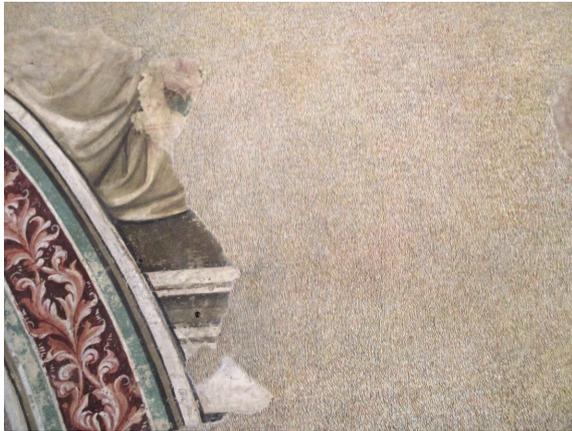
Fig. 6. Church of Santa Maria Novella, Florence (Italy), ca. 2nd half of 14th century; Photo: 2015, HAWK (Ursula Schädler-Saub) [9]

- Technique “astrazione cromatica” - Using four pure colours on a light background applied with short hatched lines, an abstract structure is created. This structure merges optically with the contiguous original (see Fig. 6).

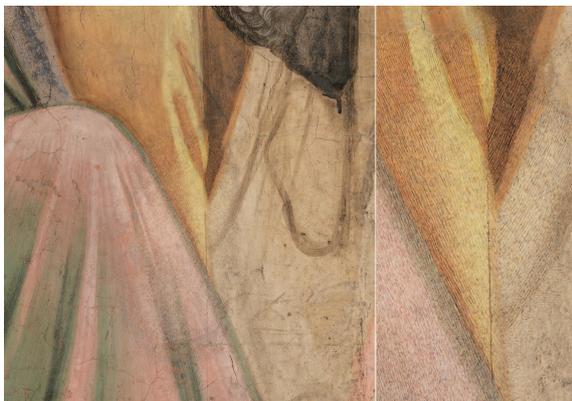
Fig. 7. Cappella Maggiore di Santa Croce, Florence (Italy) 1380, detail on the right; Photos: 2010, OPD (Maria Rosa Lanfranchi) [9]

- Technique “selezione cromatica” - The lacuna is reintegrated with short parallel lines in pure colours on a light background, which follows the shapes and contours of the original alongside them (see Fig. 7).

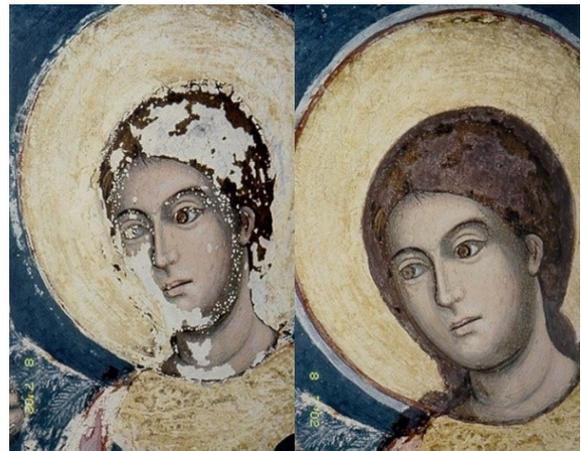
Fig. 8. The Church “Birth of the Virgin Mary” from the Monastery from One Wood, Restoration works 2001-2003 Holy Archangel Altar, Images before and after the chromatic integration in the technique – “velatura” [10]

Contemporary chromatic integration techniques solve many problems regarding the restoration of the “integrable gaps” (see Fig. 8), but they are not effective and even disturbing in cases, when “non-integrable gaps” are present (see Fig. 9).

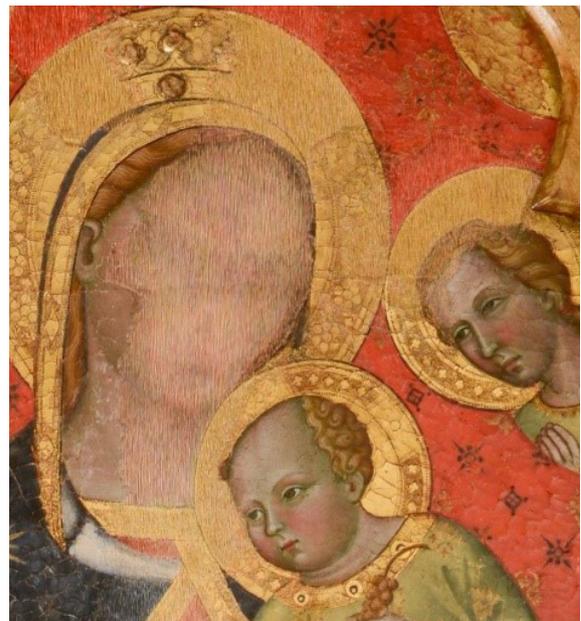
Fig. 9. The Polyptych of Frabcesco di Andrea Anquilla, Restoration works 2009-2010, integration a tratteggio con “astrazione cromatica” of the Madonna face [11]

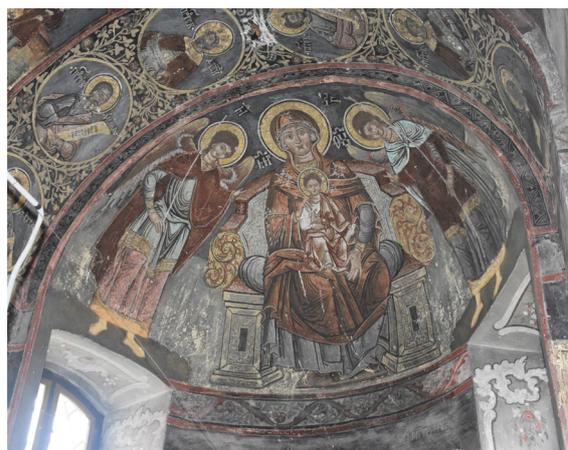
Fig. 10. Bezdin Monastery, interior mural painting [15]

An example is the interior mural painting of the church in Bezdin Monastery, located near Munar village, Arad. The mural is executed by anonymous painters in several periods. The Byzantine predominance of the paintings executed above the iconostasis and inside the ancient tower indicates a characteristic execution of the end of the XVIII century. - the beginning of the XIX century (see Fig. 10) [14].

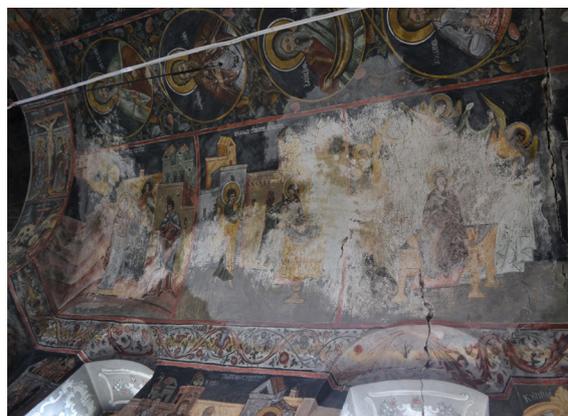
Fig. 11. Bezdin Monastery. The interior of the church, the southern part of the vault [15]

The inadequate maintenance for a long time, improper interventions, high humidity and lack of ventilation, caused the advanced degradation of the interior mural paintings of the church. In particular, the lower part of the walls, the southern and northern part of the vault and the ancient tower are affected. Cracks, exfoliations, discolourations, wiping of important surfaces, the presence of salts on the pictorial surface, the development of a fungus can be observed (see Fig. 11).

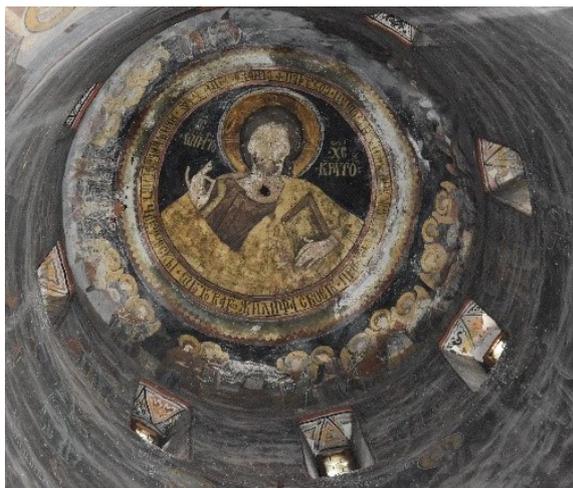
Fig. 12. Bezdin Monastery. Interior of the church, Painting from the ancient tower [15]

After performing all these interventions, the last step in the restoration process is the aesthetic integration. Due to the advanced degradation state of the painting layer (see Fig. 12), the chromatic integration is very important in the process of restoring the narrative content of the monument.

Execution of this intervention in the formal techniques of chromatic integration will lead to a fragmented image and large losses in the content of paintings. This does not mean that all gaps need to be repainted, but the details which have significant importance must be completed either based on information from the archives or even interpreted artistically.
